## WE CARE:

- Diagnostic/condition assessment of electrical assets like motors, generators, transformers, cables.
- Provides cleaning, drying, varnishing services including specialized cryogenic cleaning services on-site.

# Glimpses of our Work

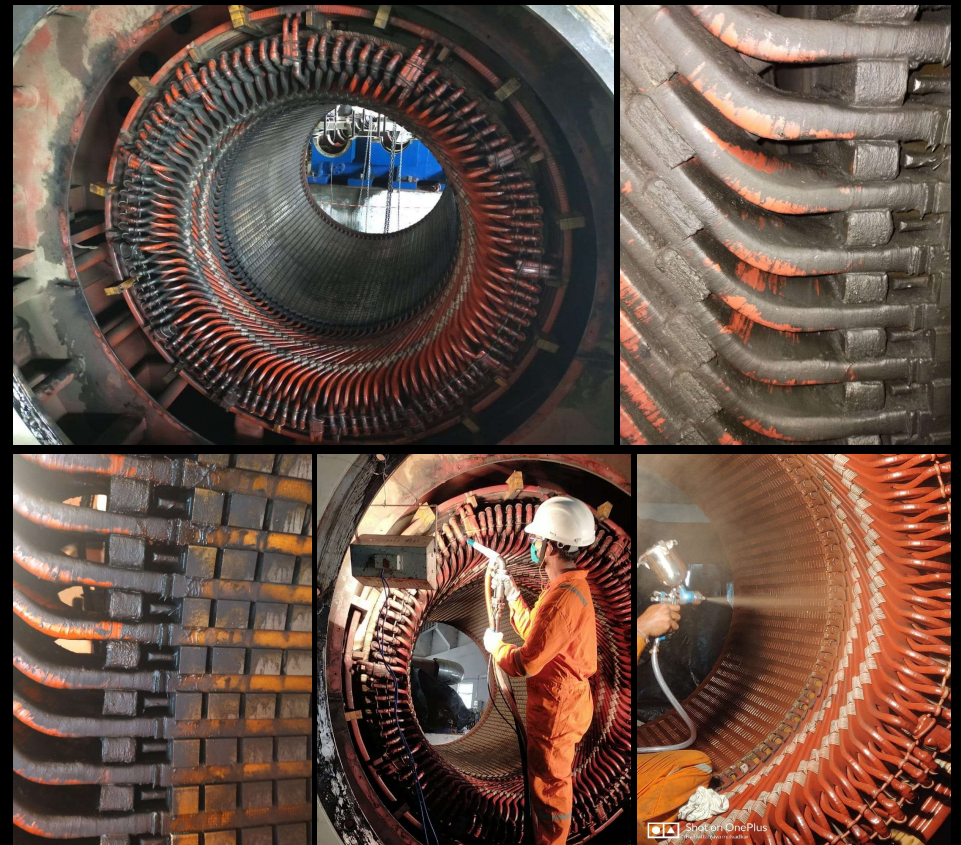
## Resolving high temperature issue

**Machine:** 37.5 MVA, 11 kV, 1500 rpm generator

**Issue:** High Operating Stator temperatures upto 100 °C.

**Observation:** The stator and rotor had excessive oil and dust contamination.

**Solution:** Solvent pre-cleaning followed by cryogenic cleaning using dry-ice, drying out and confirming the improvements in the Insulation Resistance and Polarization Index values, stator/rotor/exciter was varnished.

**Benefit:** Reduced temp - 90 °C, improved reliability, life extension

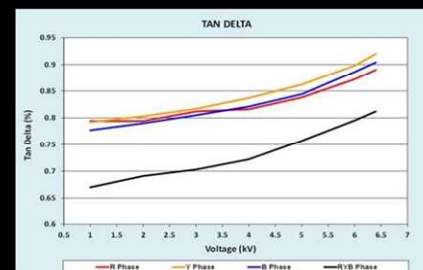
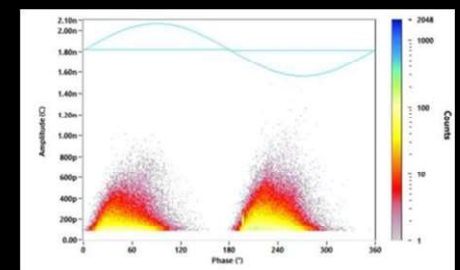
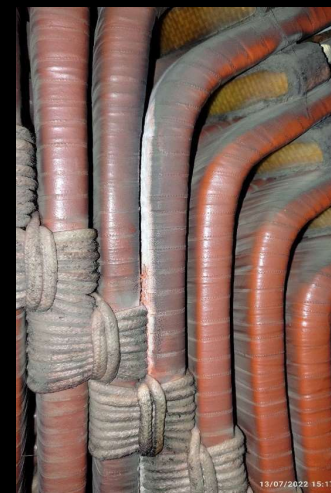
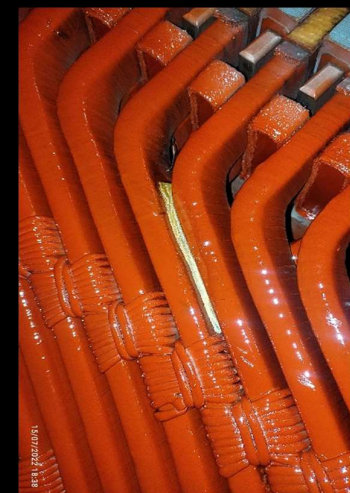
## High Partial Discharge - Overhangs

**Machine:** 22 MW, 11 kV, 1443A, 1500 rpm generator

**Issue:** Diagnostic Testing detected high end-arm PD.

**Observation:** White powder formation due to erosion of resin content of varnish layer and epoxy-resin component of ground-wall insulation.

**Solution:** Cleaning of the overhangs, varnishing, insertion of additional insulation

**Benefit:** Reduced end-arm PD, maintaining insulation life and improved reliability

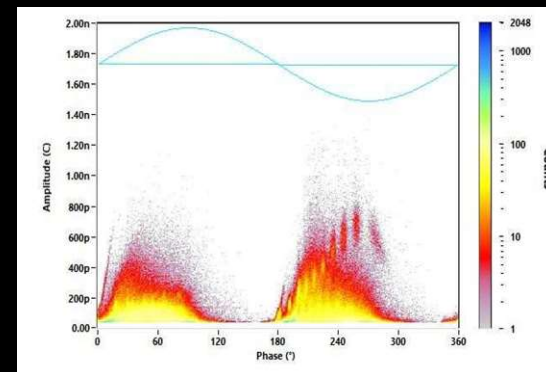
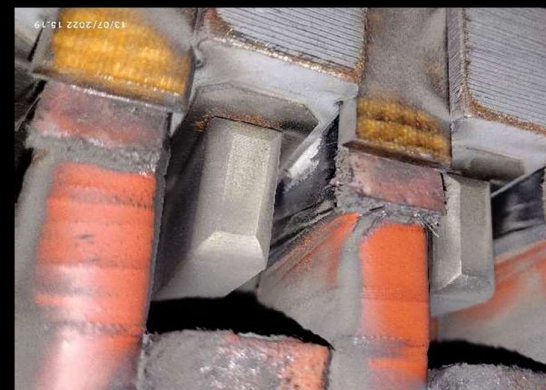
## High Partial Discharge – Slot Exits

**Machine:** 30 MW, 11 kV, 1500 rpm generator

**Issue:** Diagnostic Testing detected high energy spark gap PD.

**Observation:** White powder formation due to erosion of external stress grade tape at slot-ends.

**Solution:** Cleaning of the stator windings, application of SiC paint

**Benefit:** Reduced Slot-exit PD, maintaining insulation life and improved reliability
